ALDER MARSH DAM

NDI ID No. PA-00153  
 DER ID No. 64-150

PENNSYLVANIA GAME COMMISSION

PHASE I INSPECTION REPORT  
 NATIONAL DAM INSPECTION PROGRAM

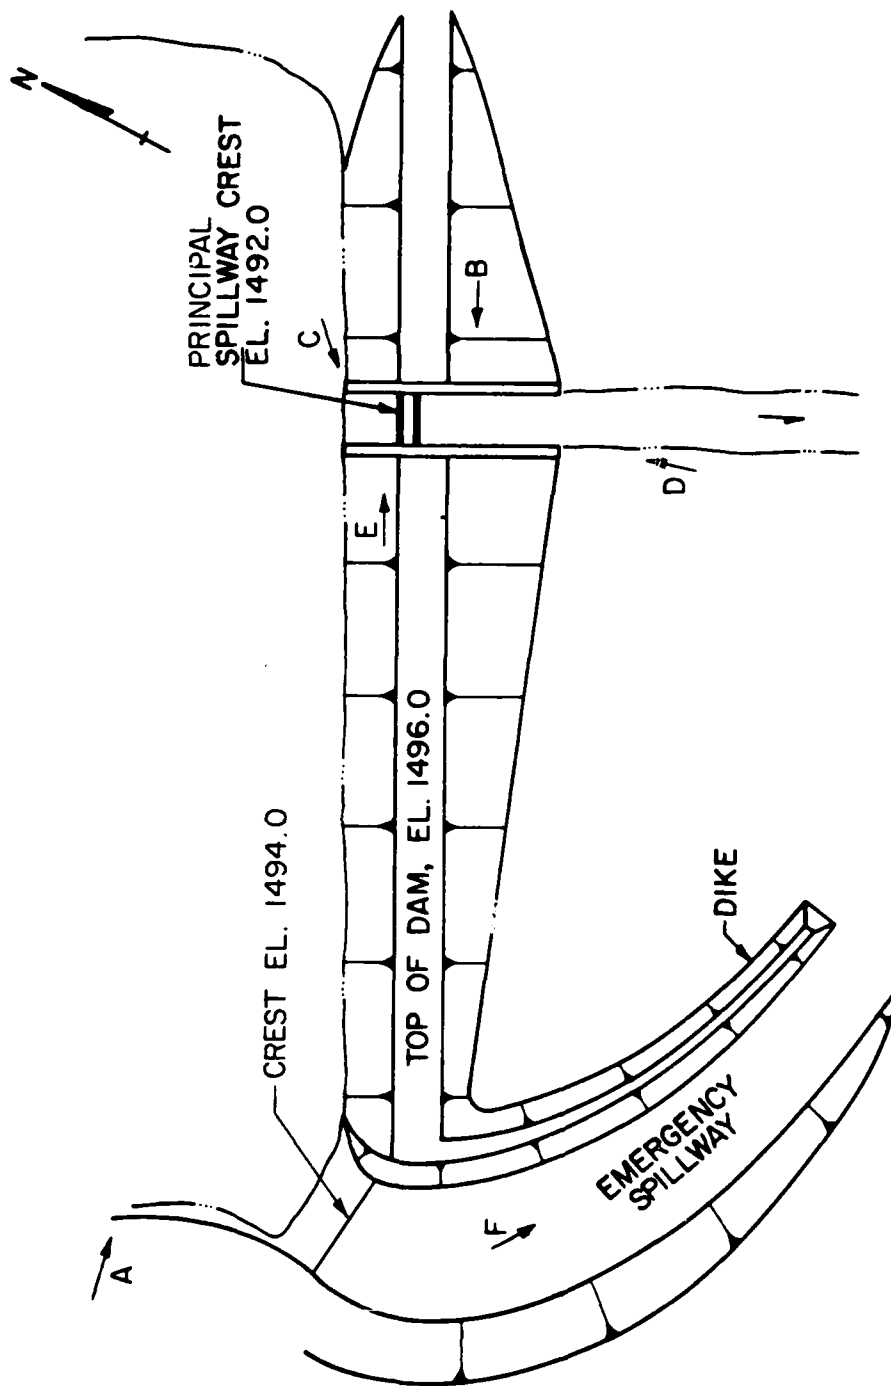
F. Emergency Spillway Channel  
(Looking Downstream)

c. Appurtenant Structures. Both spillways are in generally good condition. The area between the principal spillway stoplogs has been filled with soil and rock to reduce seepage through the stoplogs. The emergency spillway channel is well vegetated. A small dike, not shown on the design plans, was constructed along the left side of the spillway channel to prevent erosion along the toe of the embankment. The emergency spillway approach channel is smaller and has a crest elevation approximately one foot above that shown on the design plans. The existing channel has a bottom width of 53 feet and a crest elevation of 1494.0 feet, as compared with the design bottom width of 65 feet and design crest elevation of 1493.0 feet.

(3) Appurtenant Structures. No conditions were observed that would indicate that either of the spillways could not operate satisfactorily in the event of a flood. The emergency spillway approach channel is smaller than that shown on the design plans and, therefore, has a correspondingly lower discharge capacity.

(3) Spillway Adequacy. The criteria used to evaluate the spillway adequacy are described in Appendix D. Since the spillway passes less than the 1/2 PMF it is rated as inadequate. If the emergency spillway channel were widened to its design width and the crest lowered to its design elevation, the spillway would pass about 70 percent of the PMF. The spillway would then be rated as adequate.
